STS-51 PAD ABORT

8-12-93

OV103 - ENGINE 2033 (ME-2)  
FUEL FLOWMETER  
SENSOR OPEN CIRCUIT

STS-51 PAD ABORT  
FINAL REPORT

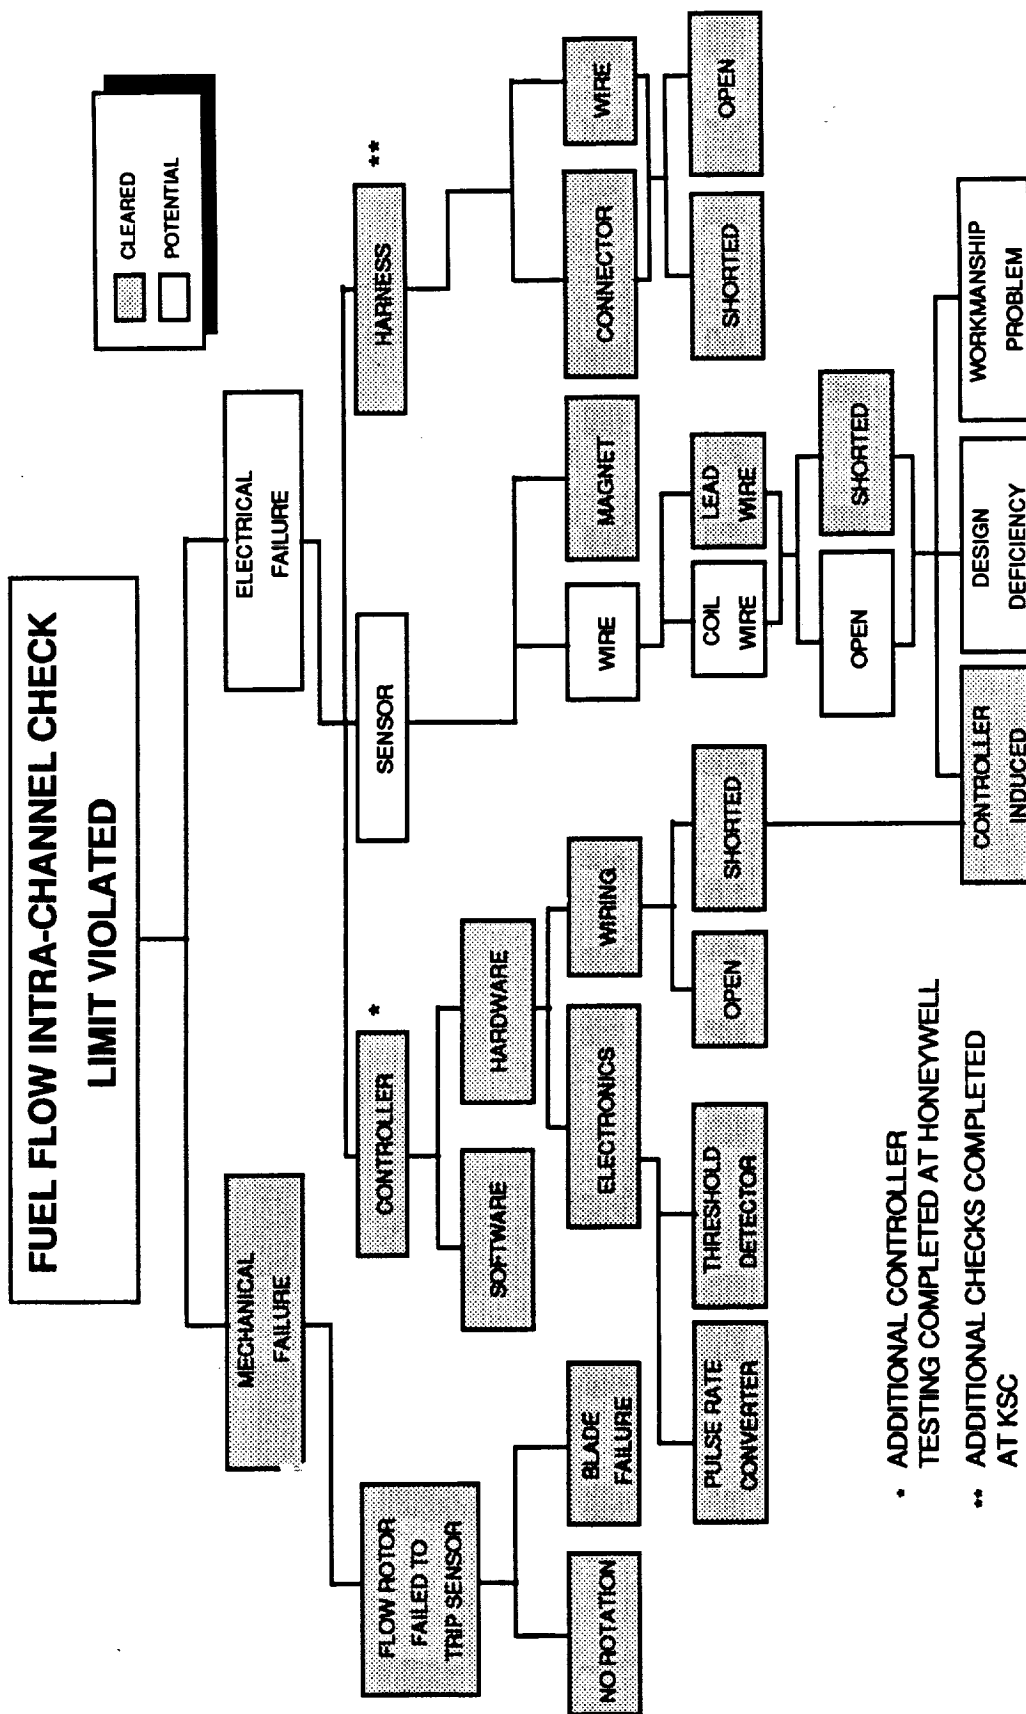
FIGURE 1

Based on the evidence completed in the investigation and application of the fault tree logic the most probable failure scenario is summarized in Figure 8.

# STS-51 LAUNCH ABORT FAULT TREE

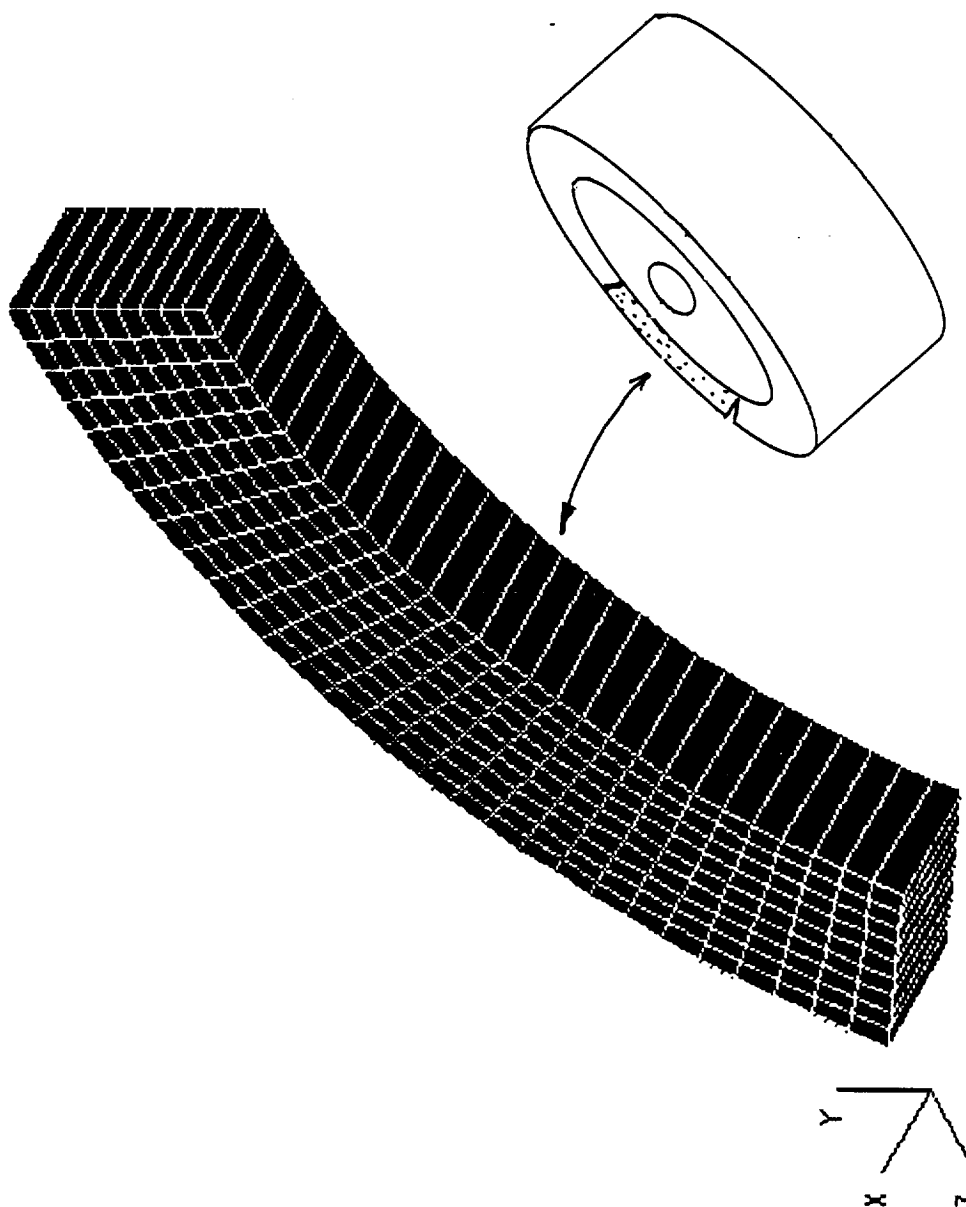
FIGURE 4

The second analytical model developed was a circumferential segment model of the epoxy layer. This model is illustrated in Figure 4 of the Attachment. This model is designed to quantify the amount of "gaping" that would result from stress relief that would occur in the event the potting developed an axial crack.

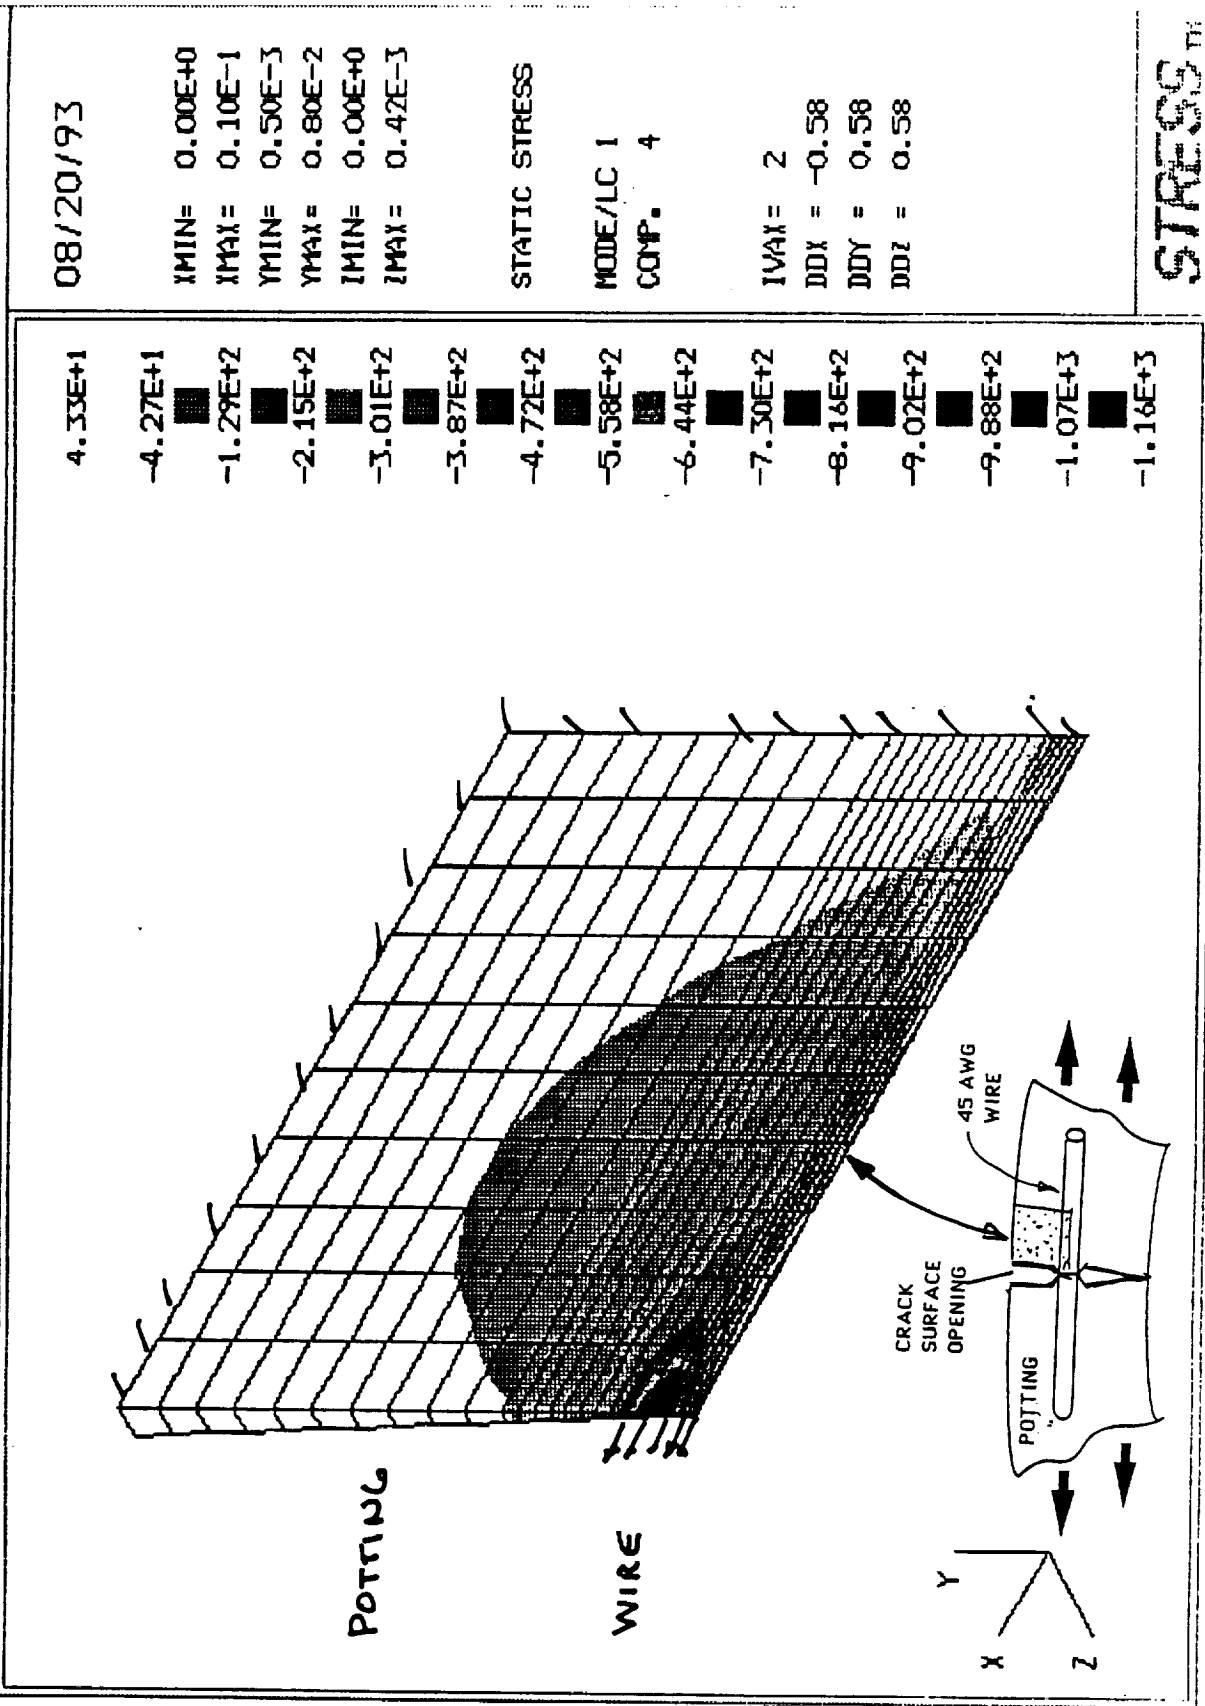
FIGURE 5

The third and final model Figure 5 simulates a single strand of 45 AWG copper wire imbedded in a semi-infinite field of epoxy. The purpose of this model is to quantify the shear stress in the bond between the wire and the epoxy as a fraction of the tensile stress of a 45 AWG copper wire imbedded in the epoxy and determine whether the bond between the wire and the epoxy would fail before the tensile strength of the wire was exceeded.

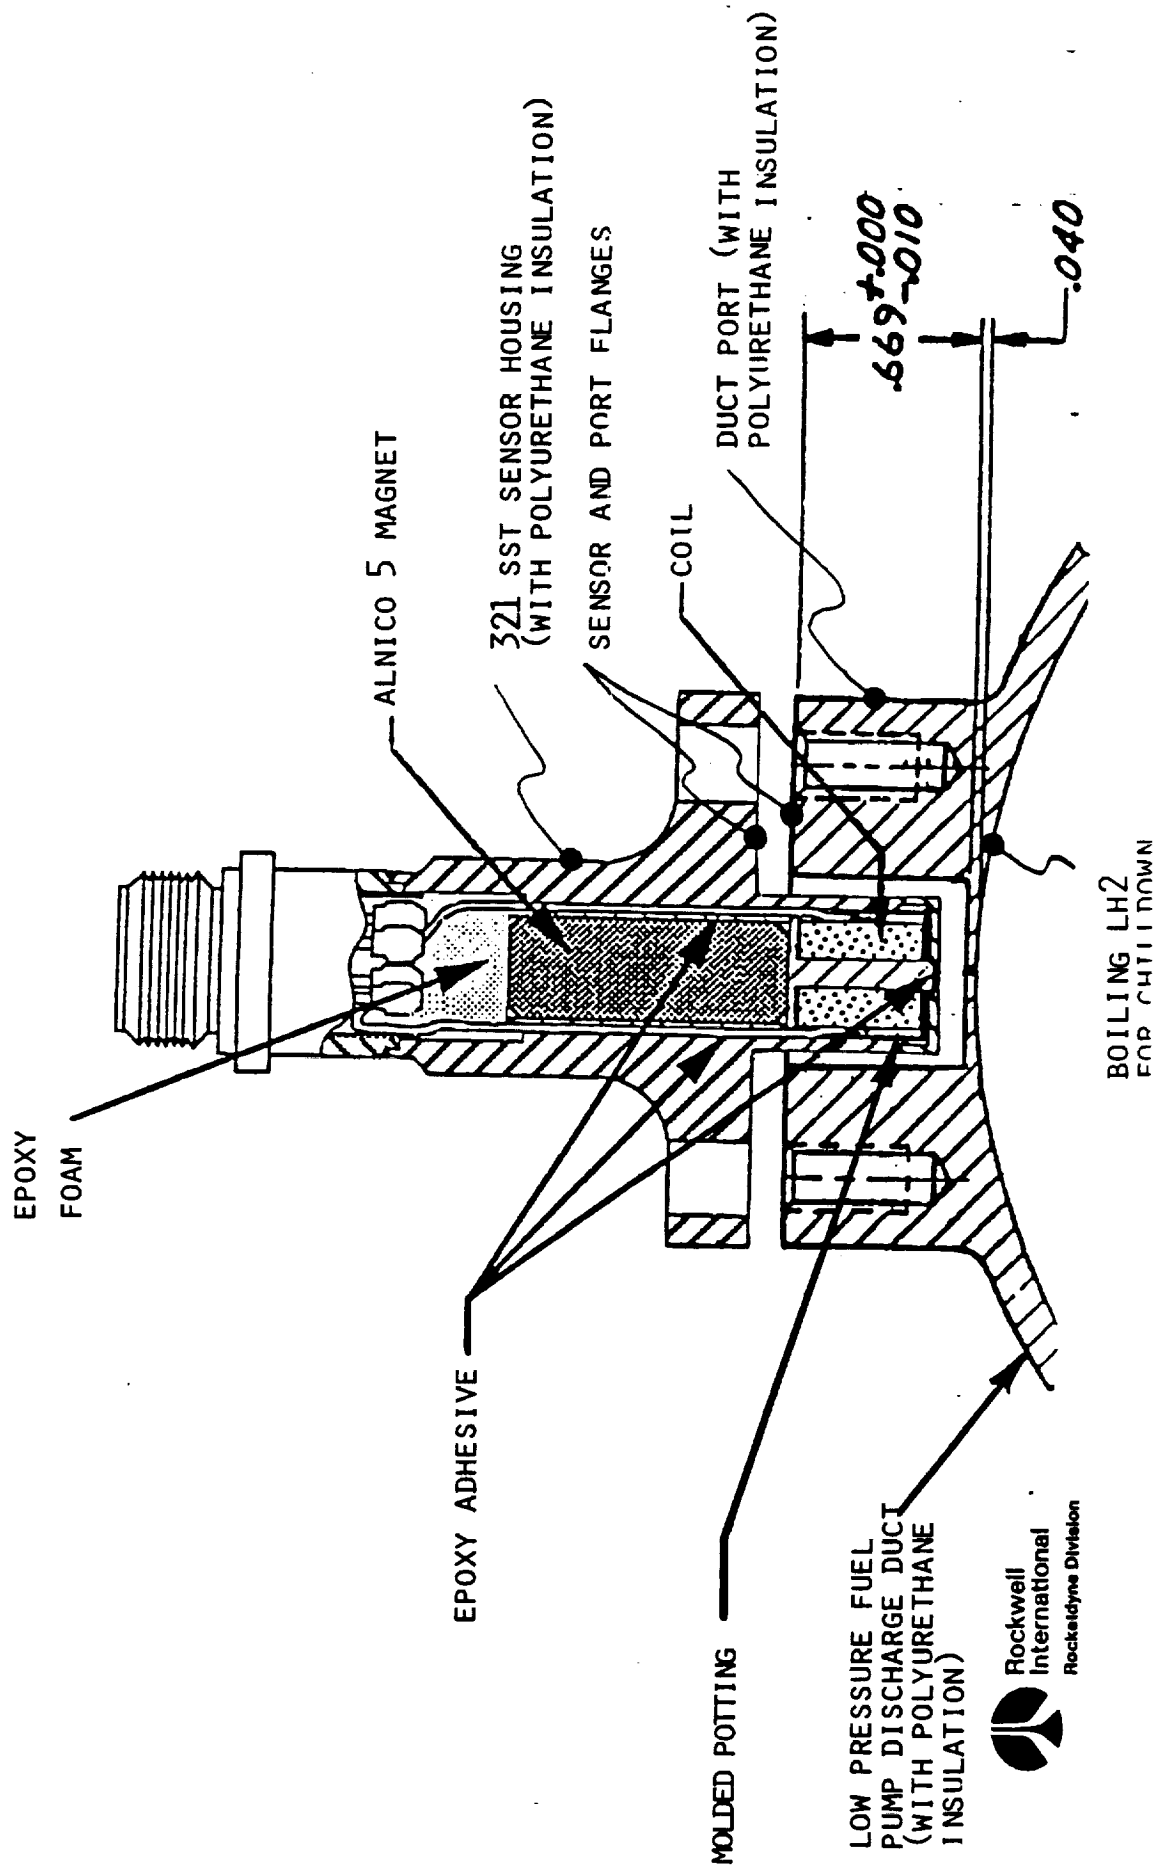
FIGURE 8

The cooling of the sensor flange and housing was done in the second step, using the calculated duct port transient temperature as the driver. The conductance across the air gaps around the sensor tip was compared with the conduction through the thickness of the sensor housing, and it was found that the latter was an order of magnitude greater than the former. Most significant was the effective contact conductance assumed between the port and sensor flanges, (Figure 7), which was studied parametrically. Later, it became evident that a contact conductance value of  $1500 \text{ Btus/hr-ft}^2\text{-}^\circ\text{R}$  is believed to be more reasonable, it can be concluded from Figure 8 that the flow sensor takes only slightly over half an hour of chill to reach steady state.

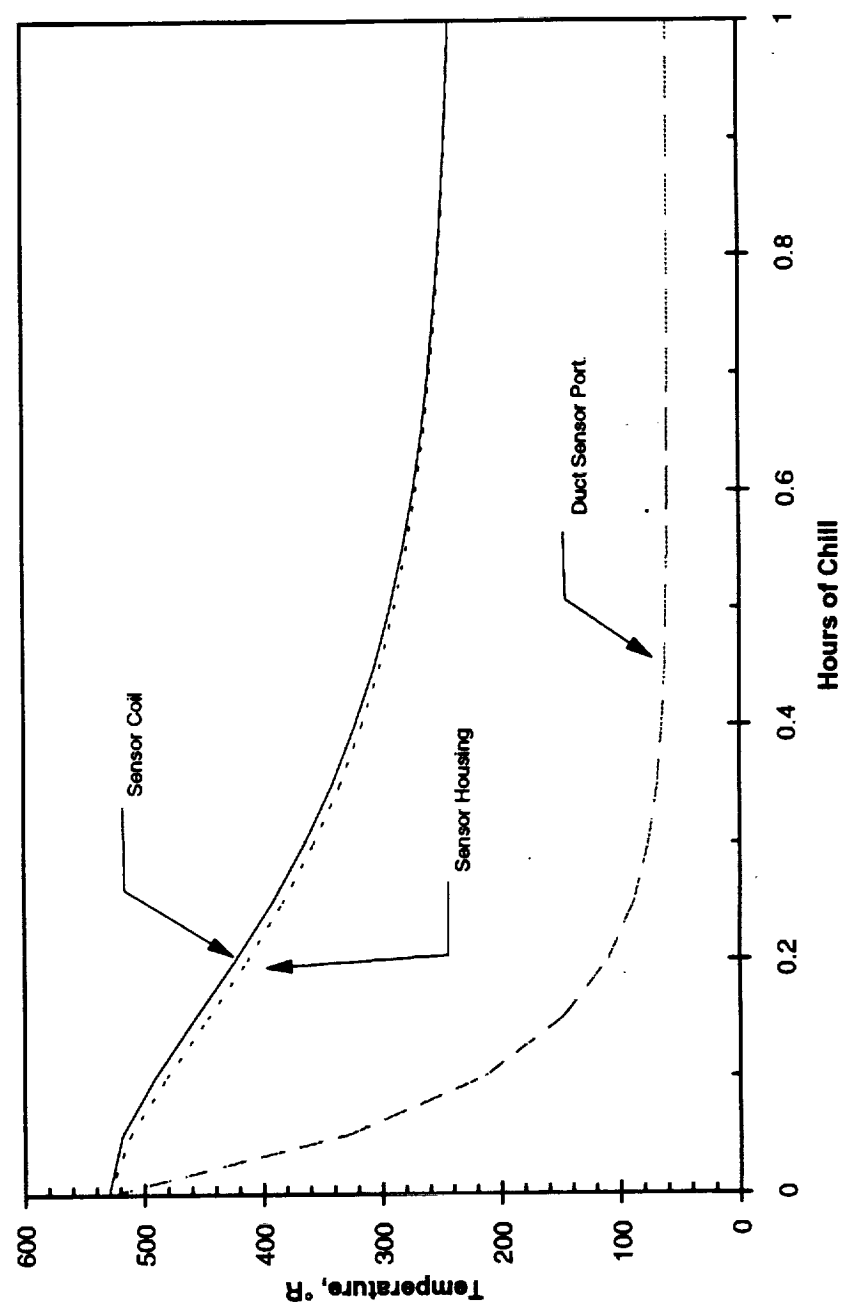
FIGURE 9  
 HPFP INLET FUEL FLOW SENSOR  
 ESTIMATED CHILLDOWN TEMPERATURE FOR SENSOR COIL AND HOUSING  
 LUMPED CAPACITANCE (QUICK) METHOD, CONTACT  $H=1500 \text{ BTU/HR-FT}^2\text{-}^\circ\text{R}$

The calculated sensor housing temperature was then used to drive the sensor coil. As anticipated, the analysis showed that the temperature difference developed between the housing and the coil is not significant due to the slow transient (Figures 8 and 9). This suggests that the  $\Delta T$  that is pertinent to the cracking of the molded potting between the housing and coil is the overall slow change of the temperature with time, and not the small gradients that develop between the sensor components during the cooldown.

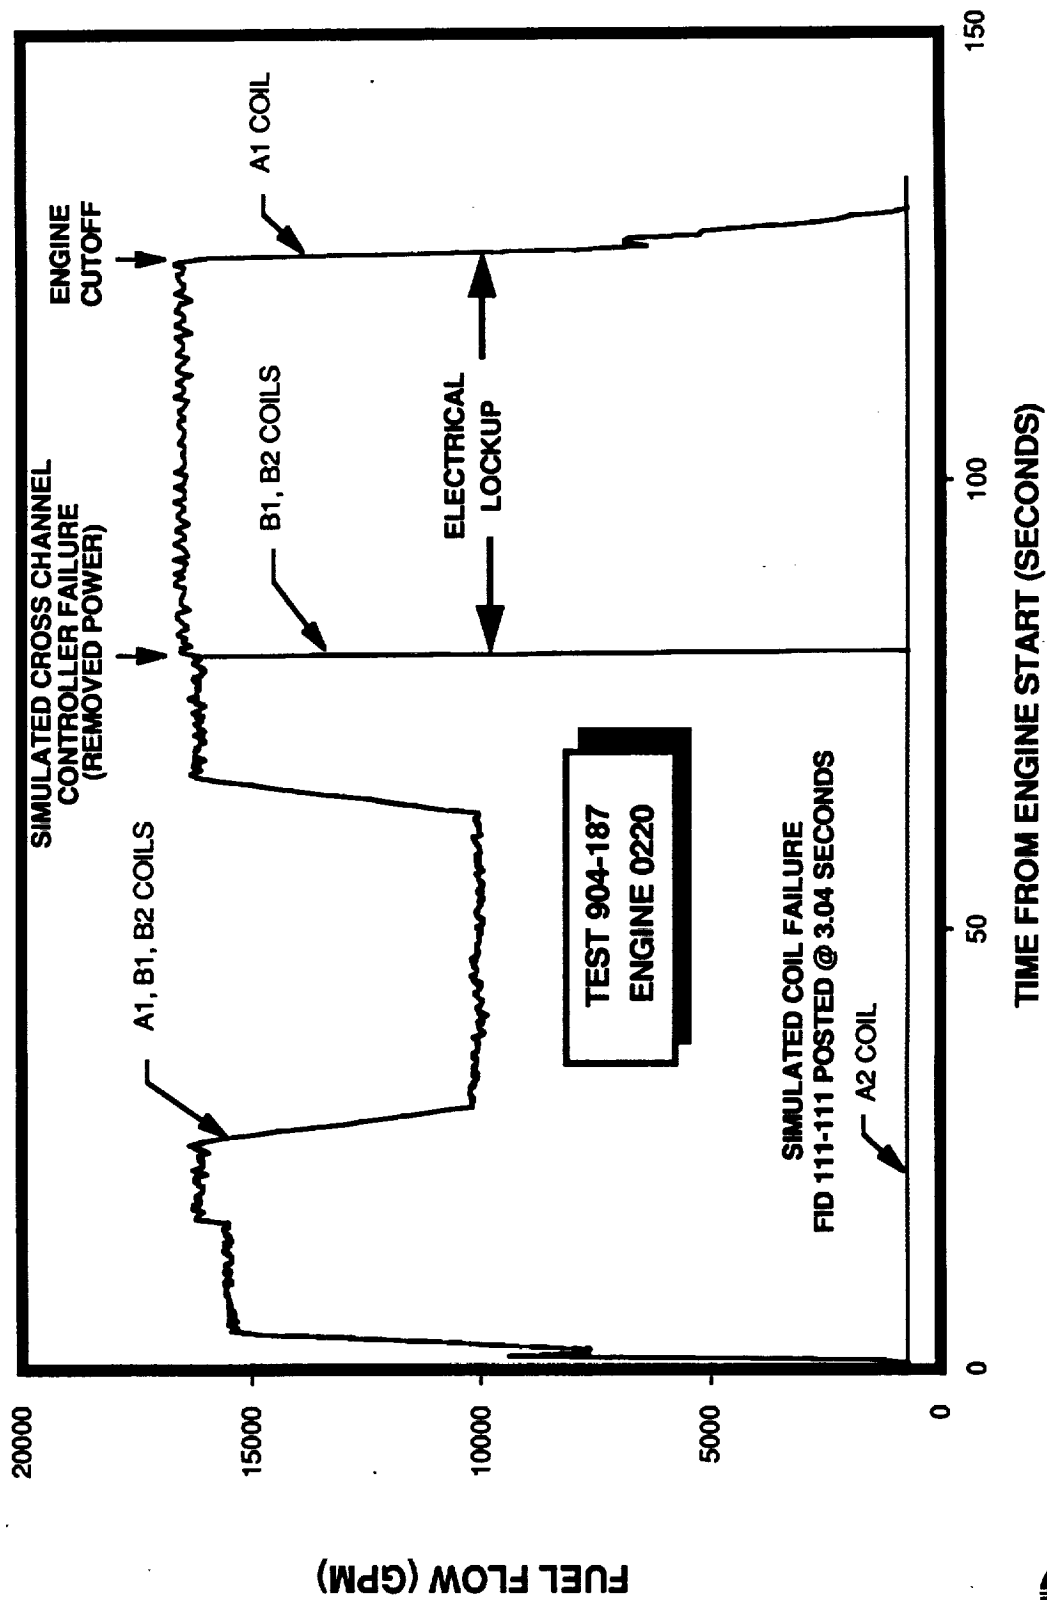
FIGURE 4

One of the actions of the Pad Abort Investigation was to initiate modification of the AA24 software to include the fuel flow sensor qualification logic in the OI-6. All of the requirement change, design, development, software test and hot fire test activities were performed on a priority basis to produce a new OI-5 software version designated RRS902M01AAAA35 (AA35). The ECP for this change was approved and all required lab and hot fire verification testing was successfully completed including a coil failure simulation and power bus failure in hot fire, (Figure 4).

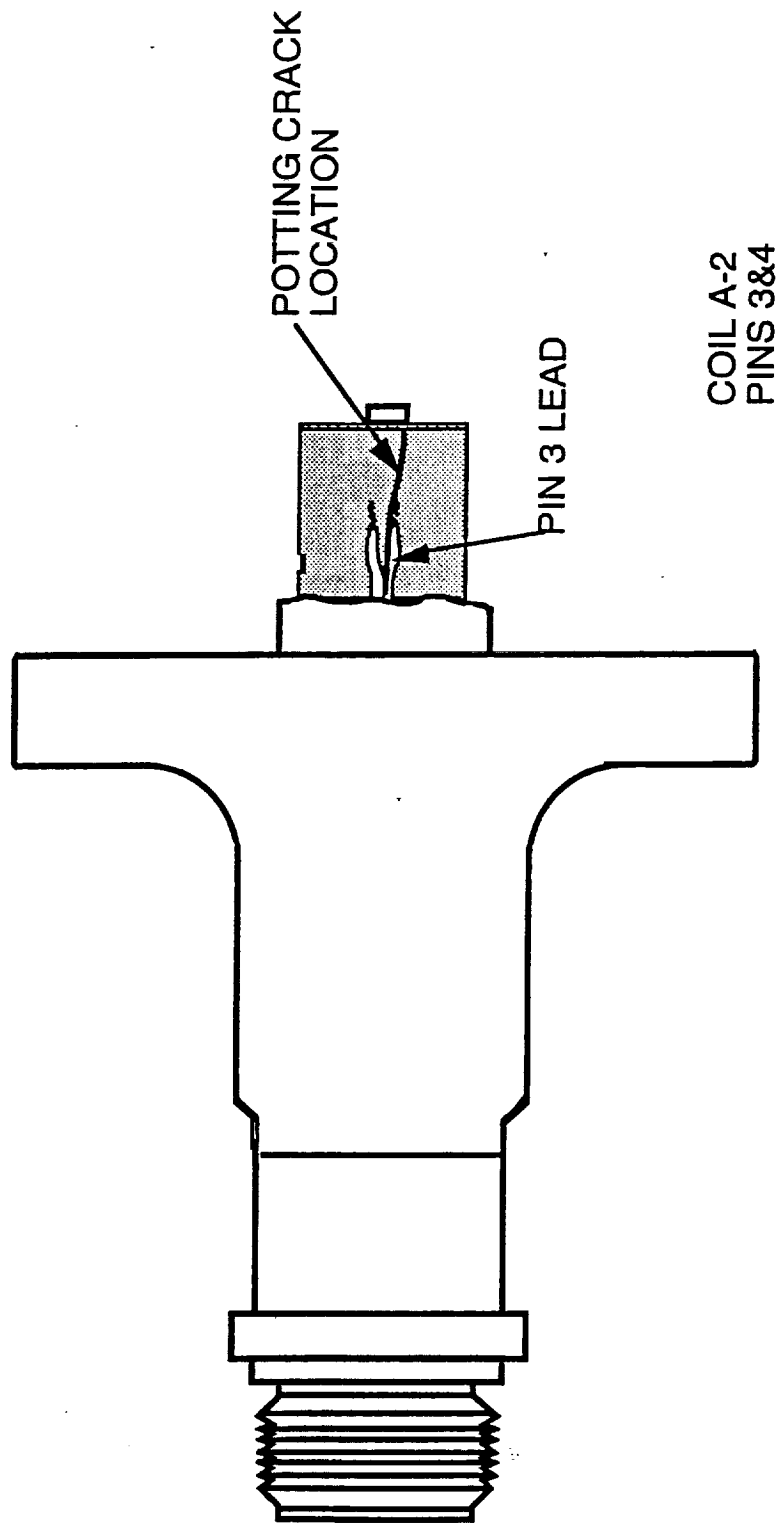
# STS-51A FUEL FLOW SENSOR

## LOCATION OF FAILURE

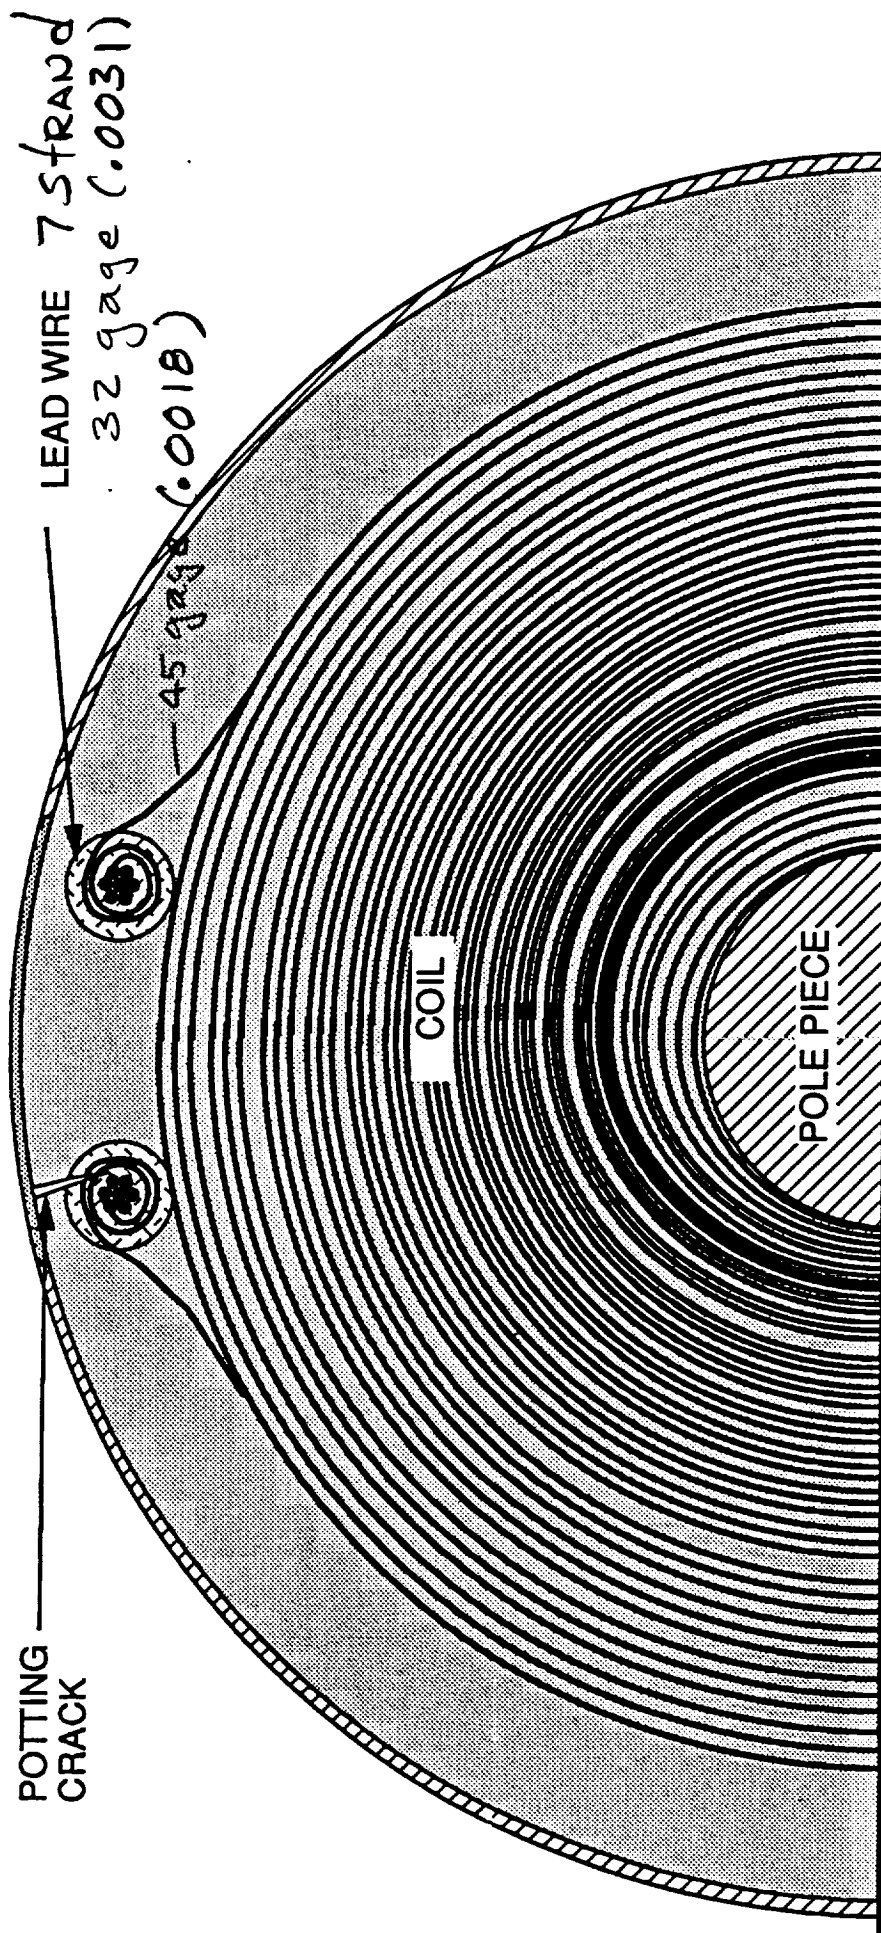
# FUEL FLOW SENSOR FAILURE MECHANISM

## FAILURE MECHANISM

- THERMAL EXPANSION COEFFICIENT MISMATCH BETWEEN THE WINDING COMPOSITE AND THE OUTER POTTING LAYER PRODUCES HIGH TENSILE STRESSES IN THE POTTING
- STRESS CONCENTRATION AT THE INSULATED LEAD WIRE IN THE POTTING MATERIAL INCREASES STRESS CAUSING FAILURE IN THE OUTBOARD LIGAMENT
- CRACK EXTENDS OR PROGRESSES CYCLICALLY ALONG THE WIRE
- IF THE CRACK INTERSECTS THE COIL WIRE, WIRE DOES NOT HAVE SUFFICIENT STRENGTH TO PREVENT POTTING MATERIAL SEPARATION
- IF THE WIRE DOES NOT DEBOND (HIGH SHEAR STRENGTH BETWEEN WIRE AND EPOXY), IT SEVERS
- BOTH ANALYSIS AND HARDWARE SHOW GOOD BOND
